Sweat-Equity Renovation

An 1890s bungalow is returned to its original beauty by an ambitious husband-and-wife remodeling crew

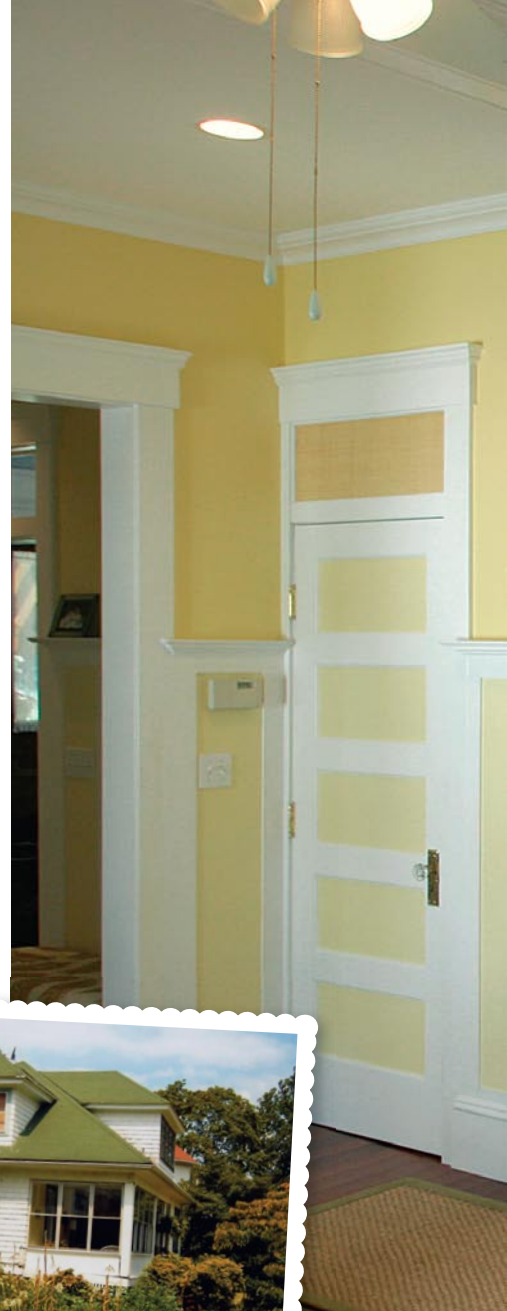
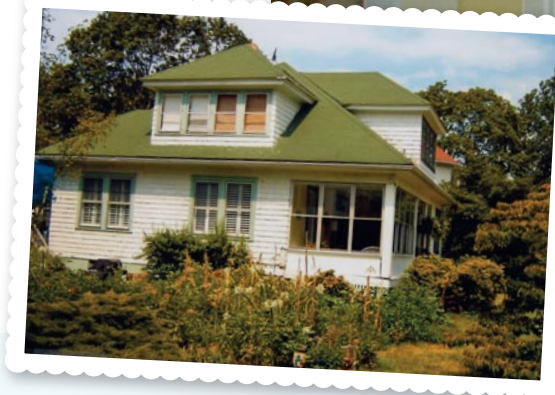
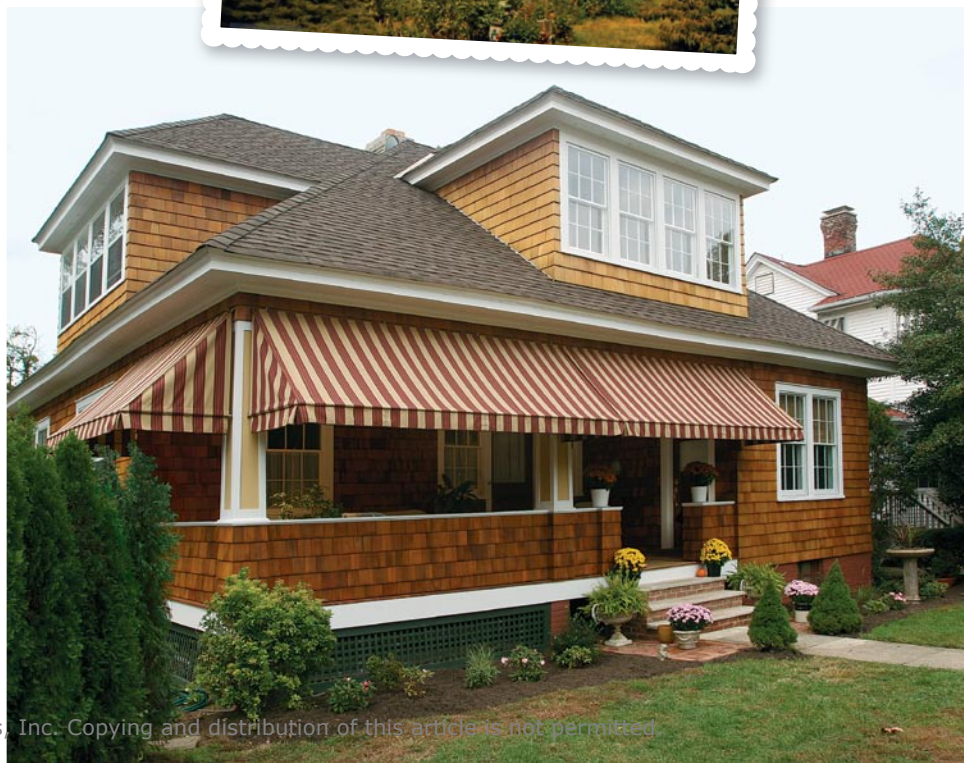
Peeling away years of "improvements." *The outside of the house was always charming, but most of the charm was hidden beneath four layers of roofing, countless layers of paint over the 100-year-old cedar siding, and a porch that was closed in by triple-track windows.*

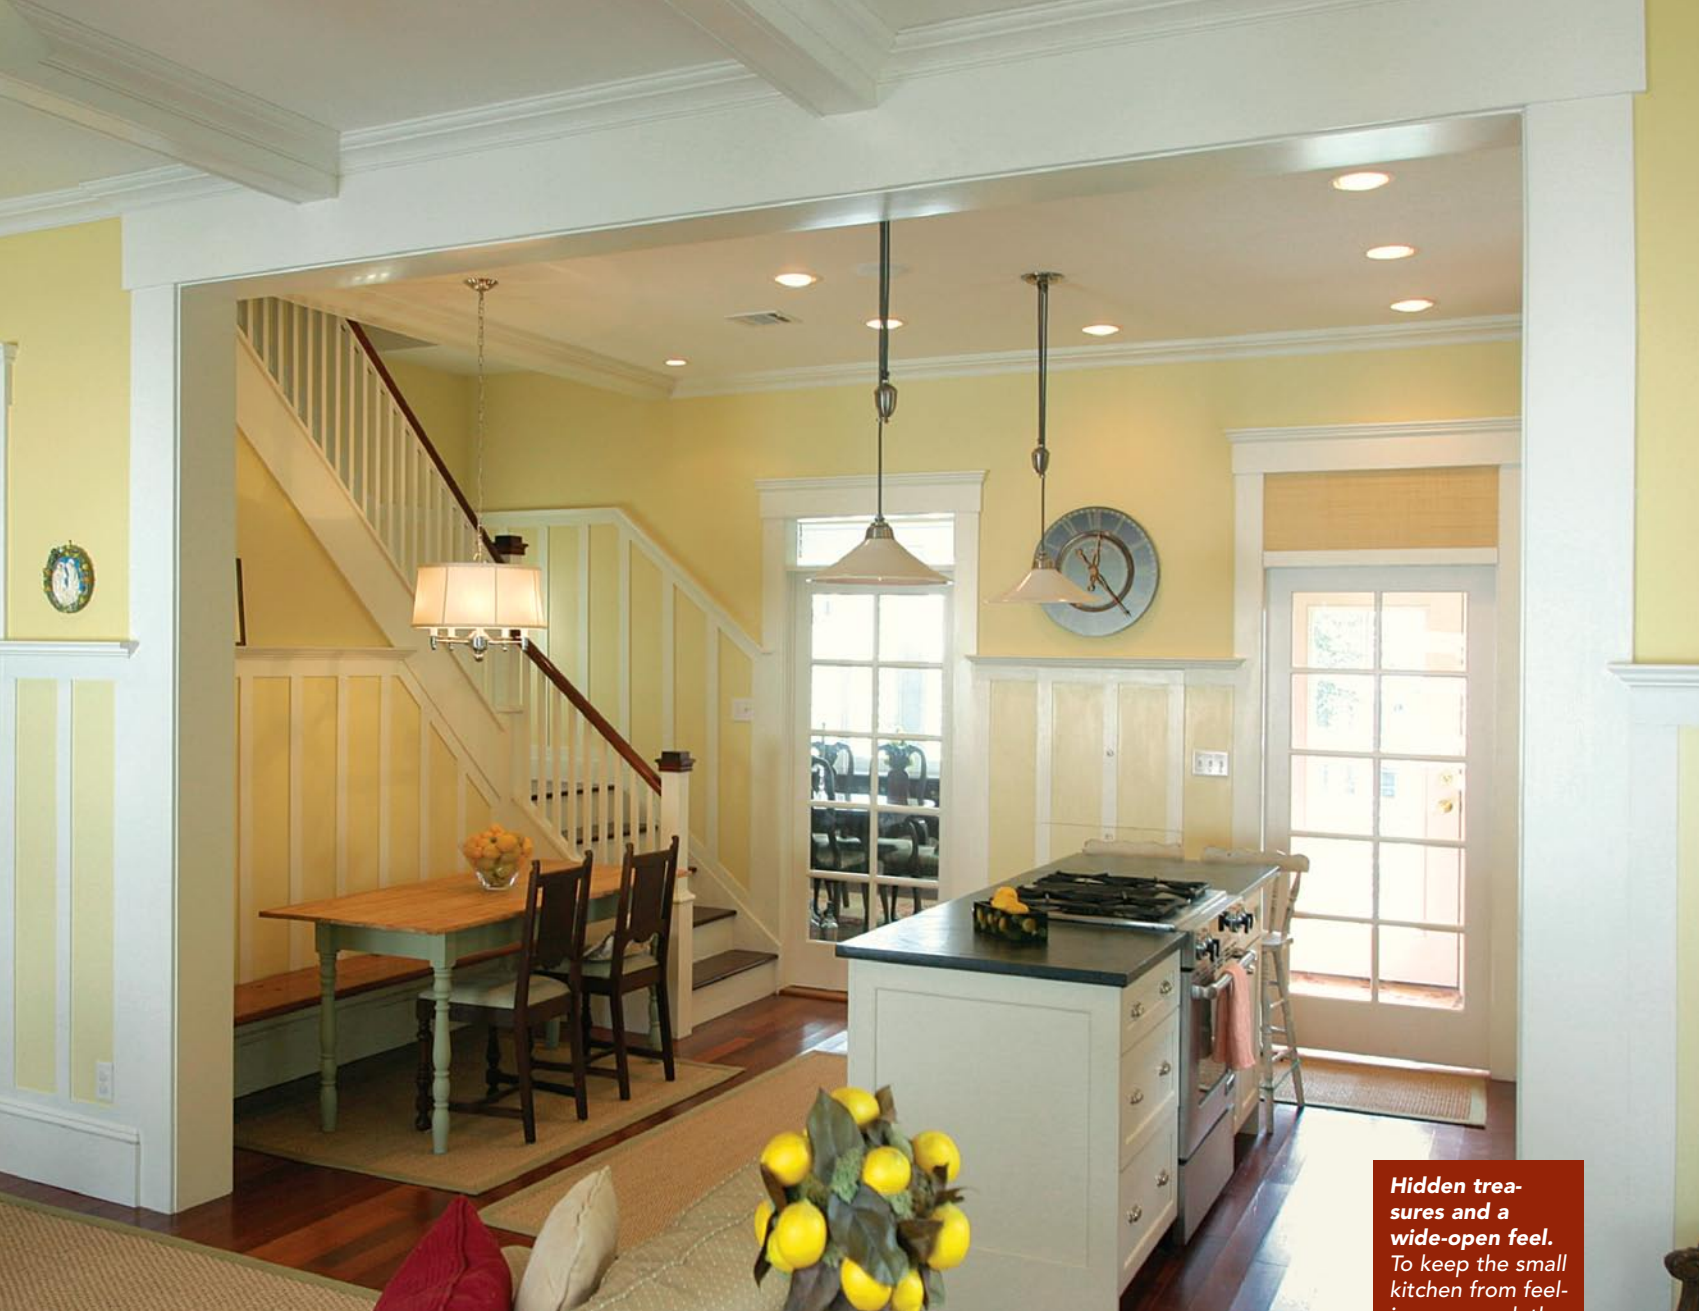
Hidden treasures and a wide-open feel. To keep the small kitchen from feeling cramped, the island is a comfortable distance from the rest of the cabinets, the kitchen table is tucked neatly at the foot of the stairs, and a pair of hidden built-ins (hint: look under the clock) keeps the recycling bins and some occasional-use appliances out of sight.

Rather than overload on cabinets, we set up a large pantry to store all our food, allowing the rest of the kitchen to be minimal and more efficient. We also designed and installed a hidden cabinet in the kitchen wainscot to house the microwave and toaster ovens, as well as a slide-out drawer below to hold the recycling bins. Another feature we felt strongly about, given the space allowed, was the additional prep area of 30-in.-deep kitchen countertops as opposed to the traditional 24-in. depth.

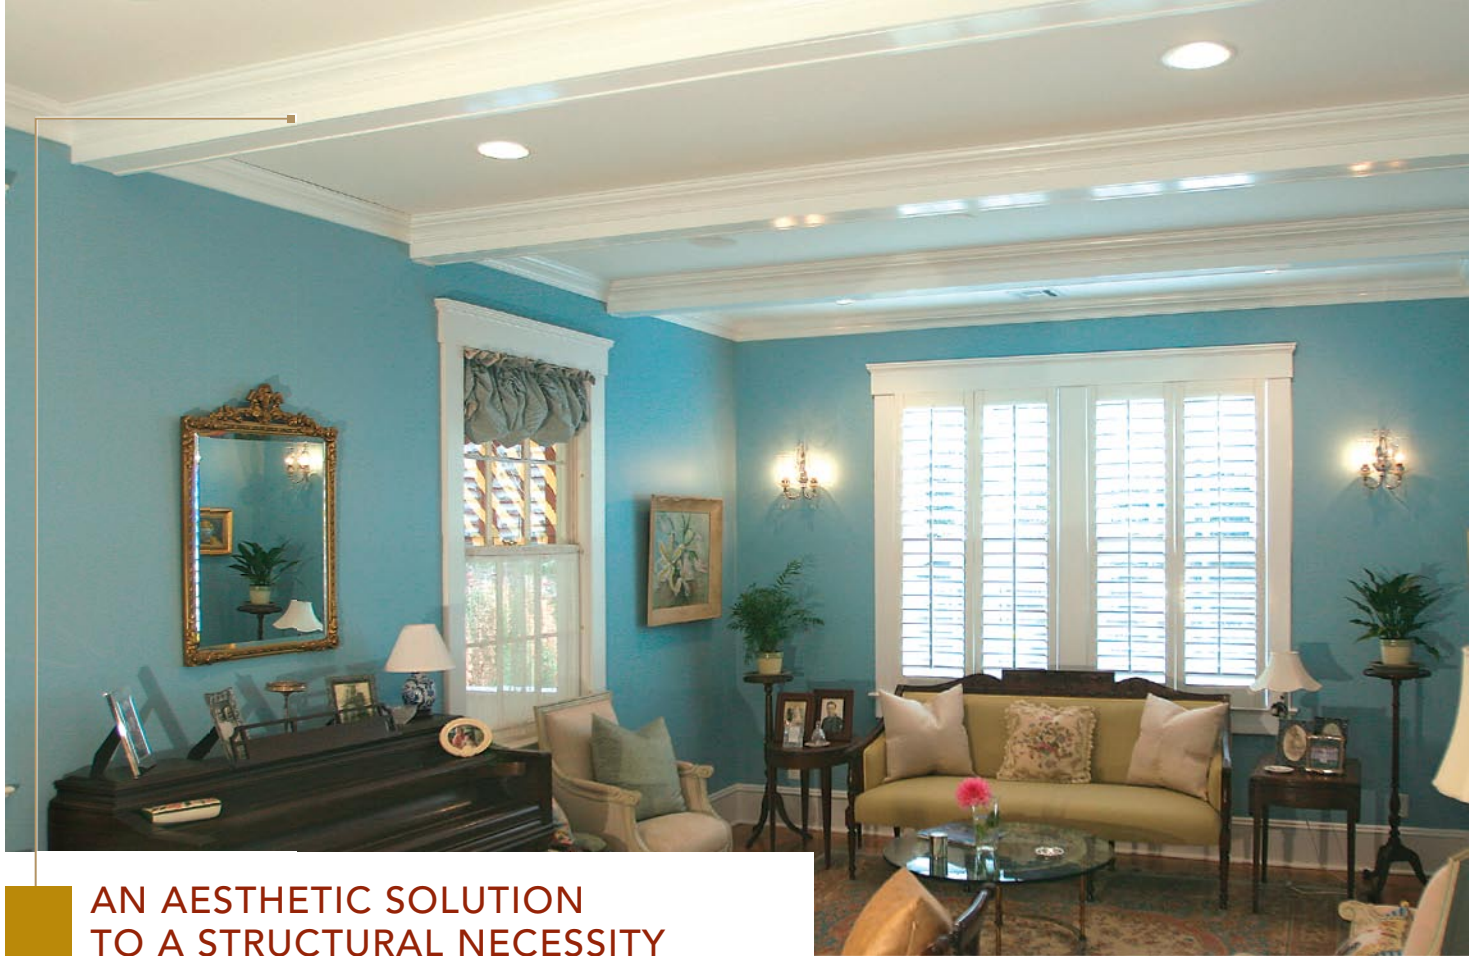
AN AESTHETIC SOLUTION TO A STRUCTURAL NECESSITY

The second floor, which had originally been an attic, was at some point converted to living space but never reinforced to carry the extra load. To support the existing floor joists, which were beyond their maximum span, the homeowners ran new structural beams perpendicular to the joists. The new beams also provided enough room to run 6-in. HVAC ductwork and became a starting point for a classy box-beam ceiling.

The only two rooms that remained largely the way we found them were the living room and the dining room. In fact, the wainscoting in the dining room—covered by so many layers of paint that the trim profiles were almost completely obscured—was inspiration for the rest of the downstairs. The only change to the living room was the addition of a box-beam ceiling, which was an aesthetic solution to a structural necessity. The second floor, which had originally been an attic, was at some point converted to living space but never reinforced to carry the extra load. We added structural beams under the existing joists and dressed them up with trimwork (drawing p. 72).

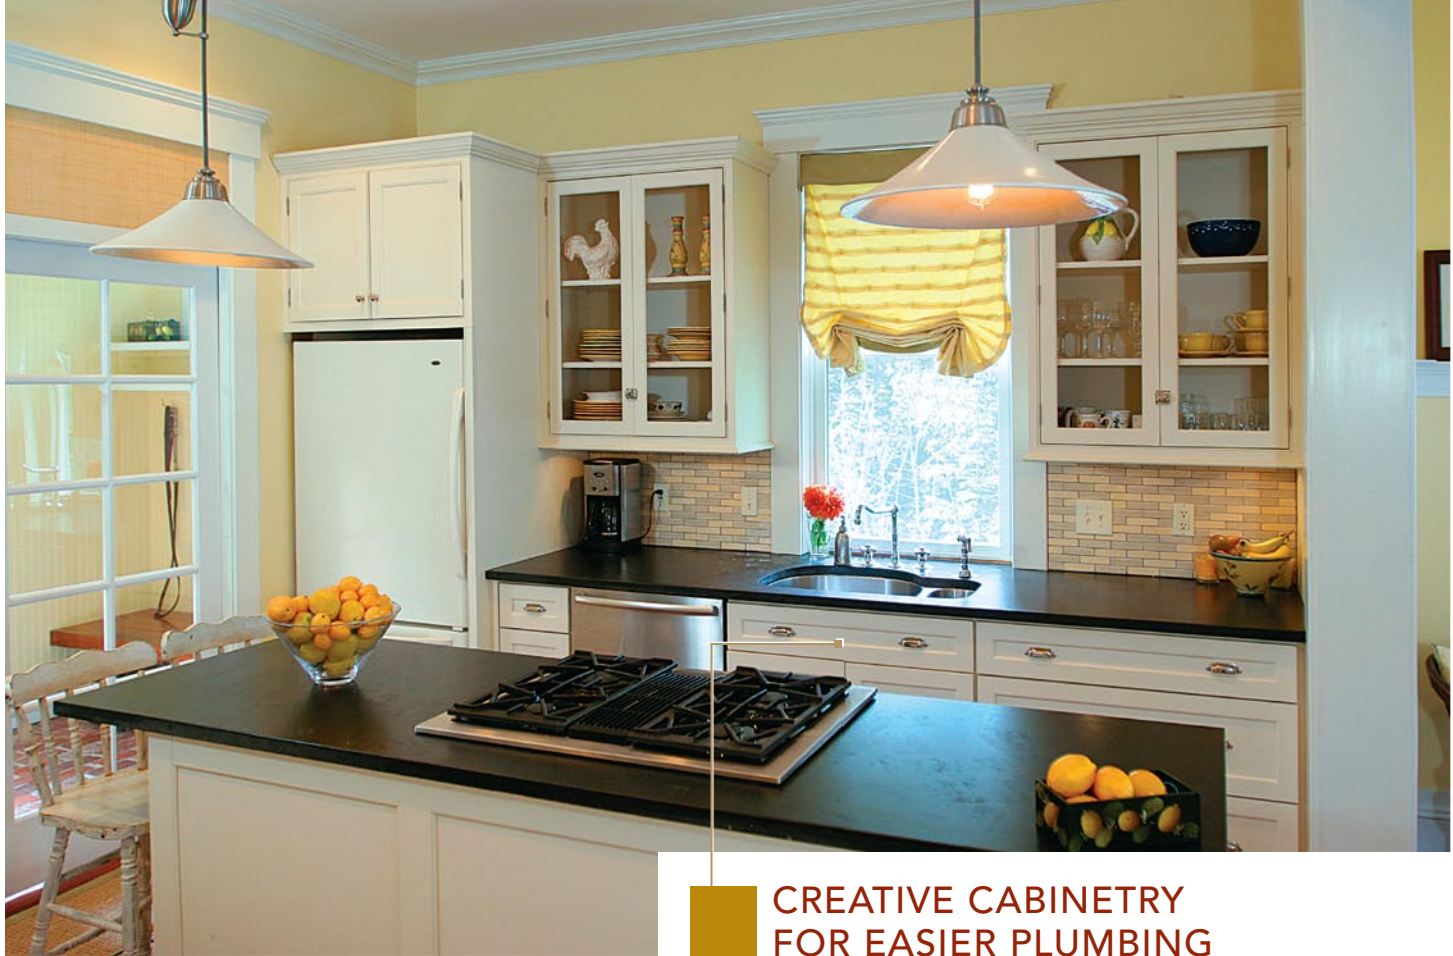
CREATIVE CABINETRY FOR EASIER PLUMBING

After removing the existing kitchen cabinets, the homeowners found that the load-bearing wall studs had been notched heavily to run the sink's waste pipe. After replacing the damaged studs, they sidestepped the structural problem by installing a 27-in.-deep sink cabinet flanked by standard 24-in. cabinets. Kept flush on the front face, the different-depth cabinets created a 3-in. space in the back to route the drainpipe. As a bonus, the added depth allowed for deeper countertops.
