How to Save an

A historic Cape gets a dry basement and an insulation upgrade

BY STEVE BACZEK

without losing its traditional character

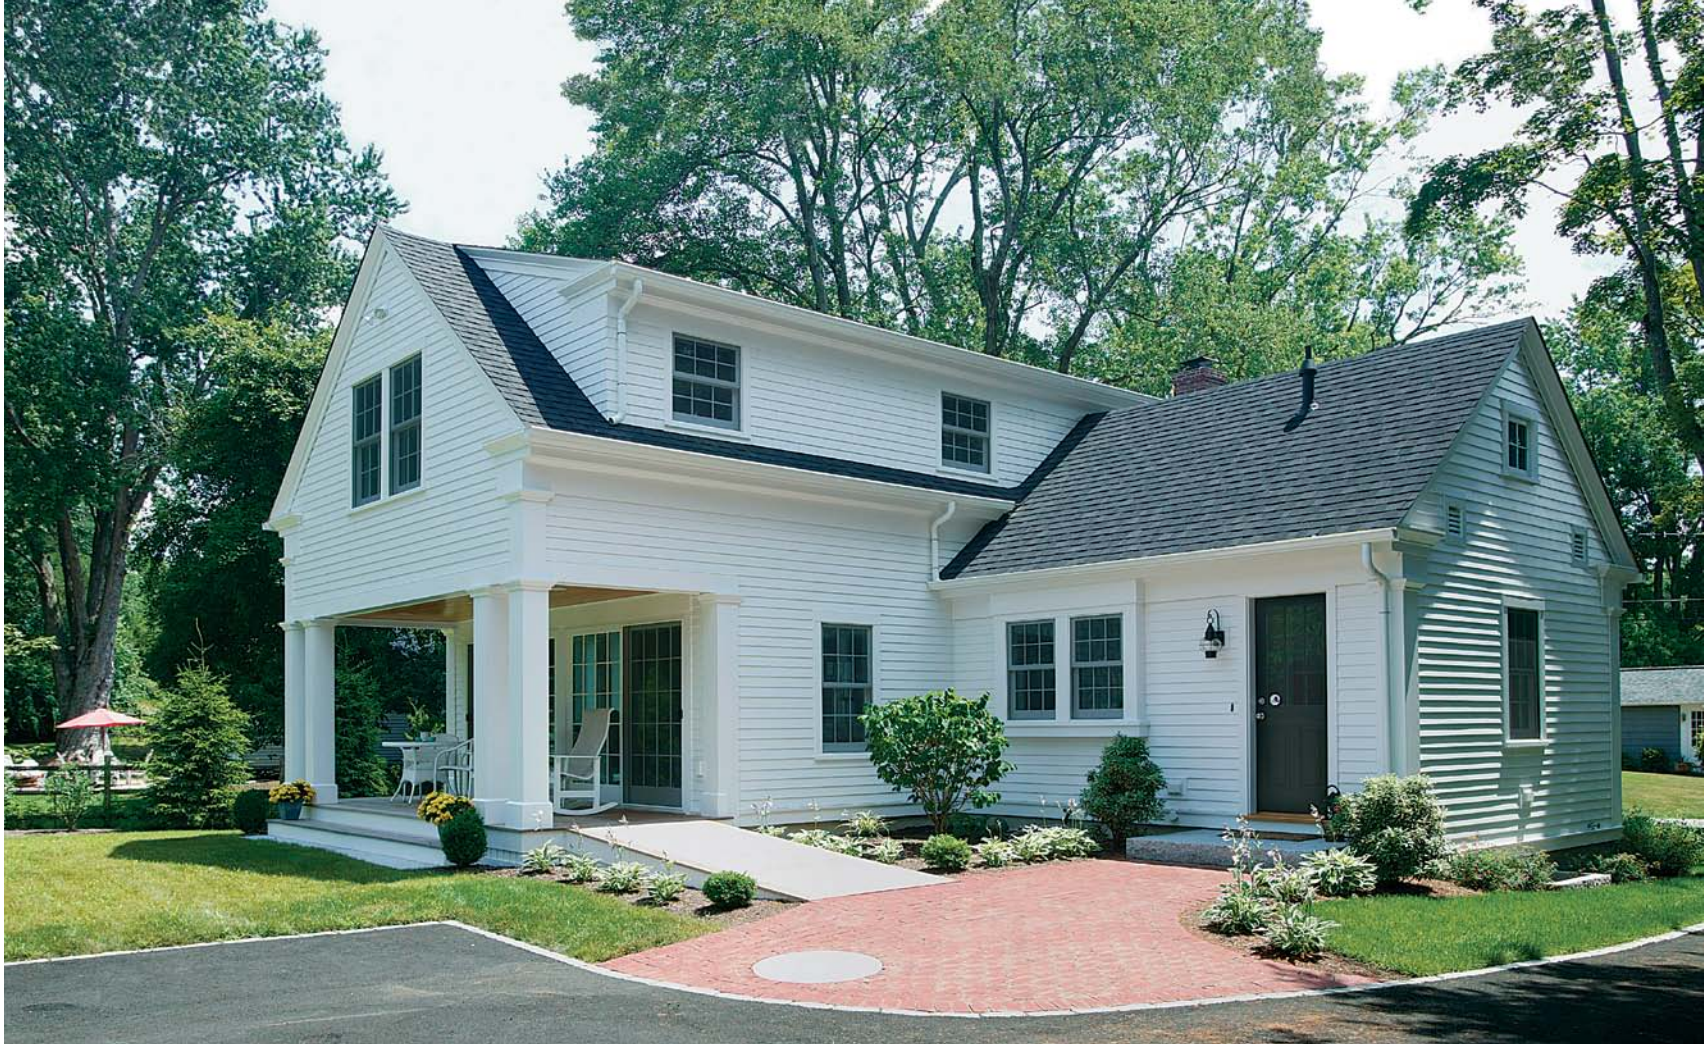
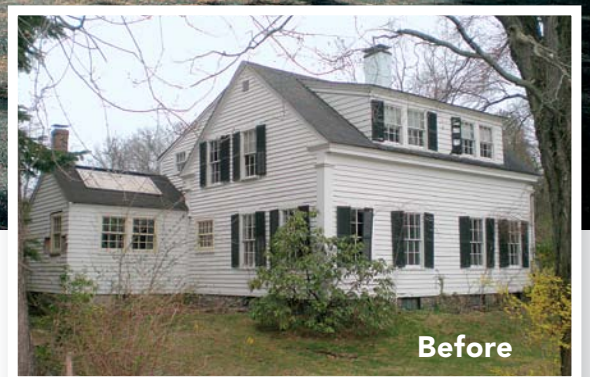
The new addition's location on the back of the house (large photo above) allows the house's front elevation to remain faithful to the original (inset photo and photo facing page). The addition houses a modern kitchen and family room on the first floor and a master suite upstairs.

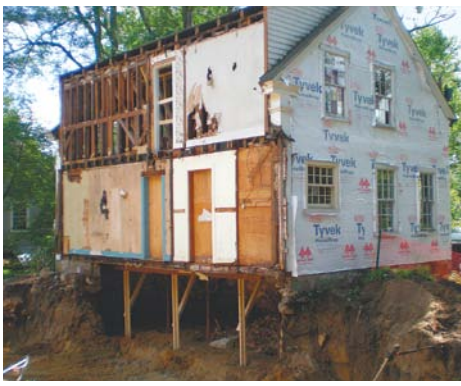
First phase: demolition. After the old additions were peeled away, the main part of the house was supported over the excavated basement in preparation for new construction.
